**NASHUA RIVER BASIN  
CLINTON, MASSACHUSETTS**

**COACHLACE POND DAM  
MA 00106**

# **PHASE I INSPECTION REPORT NATIONAL DAM INSPECTION PROGRAM**

**OCTOBER 1978**

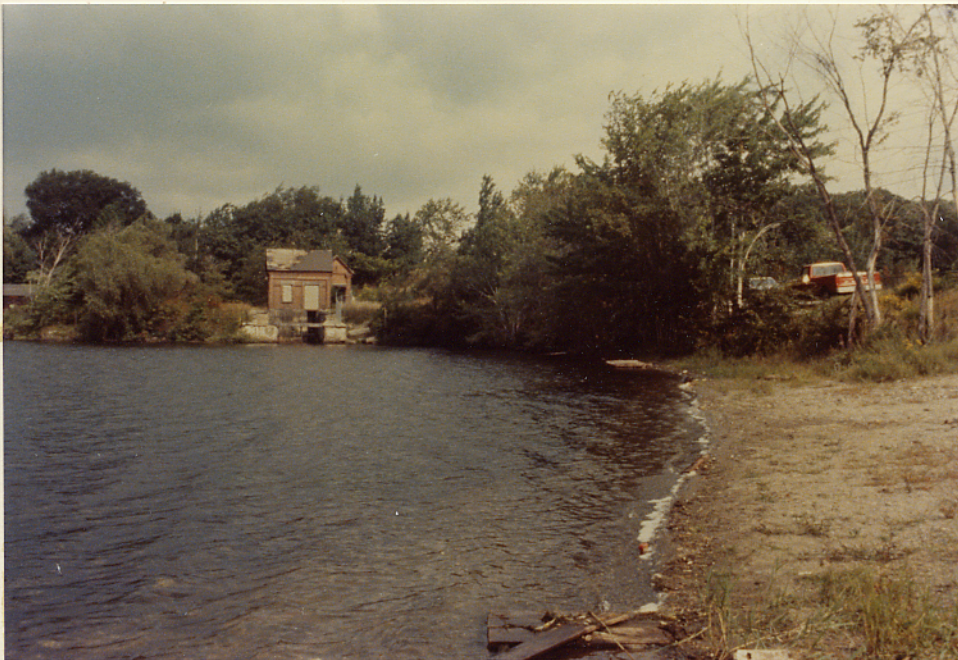
**VIEW FROM UPSTREAM OF SOUTH ABUTMENT**

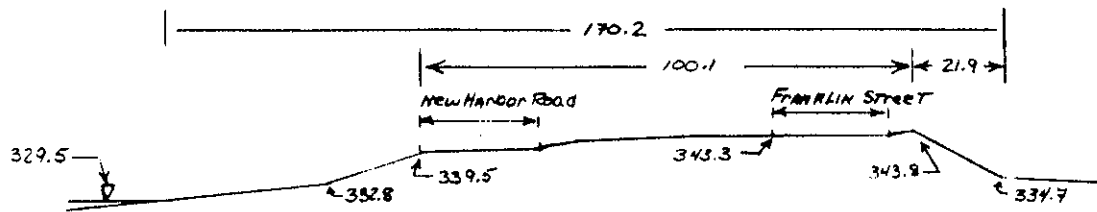
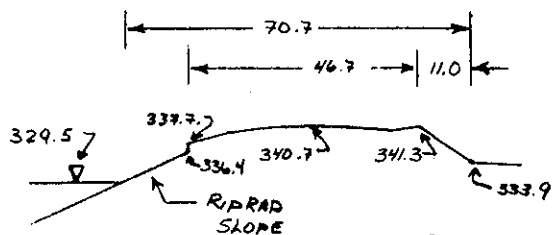
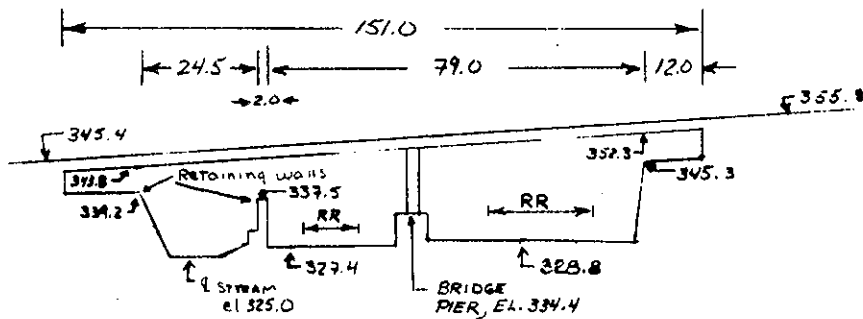
METCALF & EDDY, INC. BOSTON, MA.		U.S. ARMY ENGINEER DIV. NEW ENGLAND CORPS OF ENGINEERS WALTHAM, MA.	
NATIONAL PROGRAM OF INSPECTION OF NON-FED. DAMS			
COACHLACE POND DAM			
FIGURE B-2 SECTIONS OF DAM			
TRIBUTARY NASHUA RIVER		MASSACHUSETTS	
SCALE: 1" = 40'		DATE: OCTOBER, 1978

- b. Dam. Coachlace Pond dam is an earthfill dam with two merging roads on the crest and a stone wall along part of the top of the upstream slope. The earth embankment is generally in fair condition. The crest of the dam is mostly covered with asphalt pavement which is in good condition. Along the upstream edge of the crest, there is a wall 1.5 feet high made of cut granite blocks and extends from near the gate house to near the intersection of Old Harbor Road and Franklin Street. The wall does not appear to be a structural element of the dam, and may have been built to support the pipe railing which is on top. The wall is tilted in the upstream direction, and the pipe railing is collapsing in places. The earth slope along the bottom of the wall down to the water surface is covered with loose riprap. This slope is thickly overgrown with brush and trees 6 to 12 inches in diameter. From the southeast end of the stone wall to the southeast abutment, the upstream face of the dam is a sandy slope which is not covered or riprapped. Wave action from the pond and surface runoff from New Harbor Road have eroded this portion of the upstream face of the dam. Localized erosion from surface runoff has also occurred on the upstream slope at a low spot near the midpoint of the dam and at the approach channel to the gate house. The downstream face of the dam is in good condition. No seepage was observed and the slope

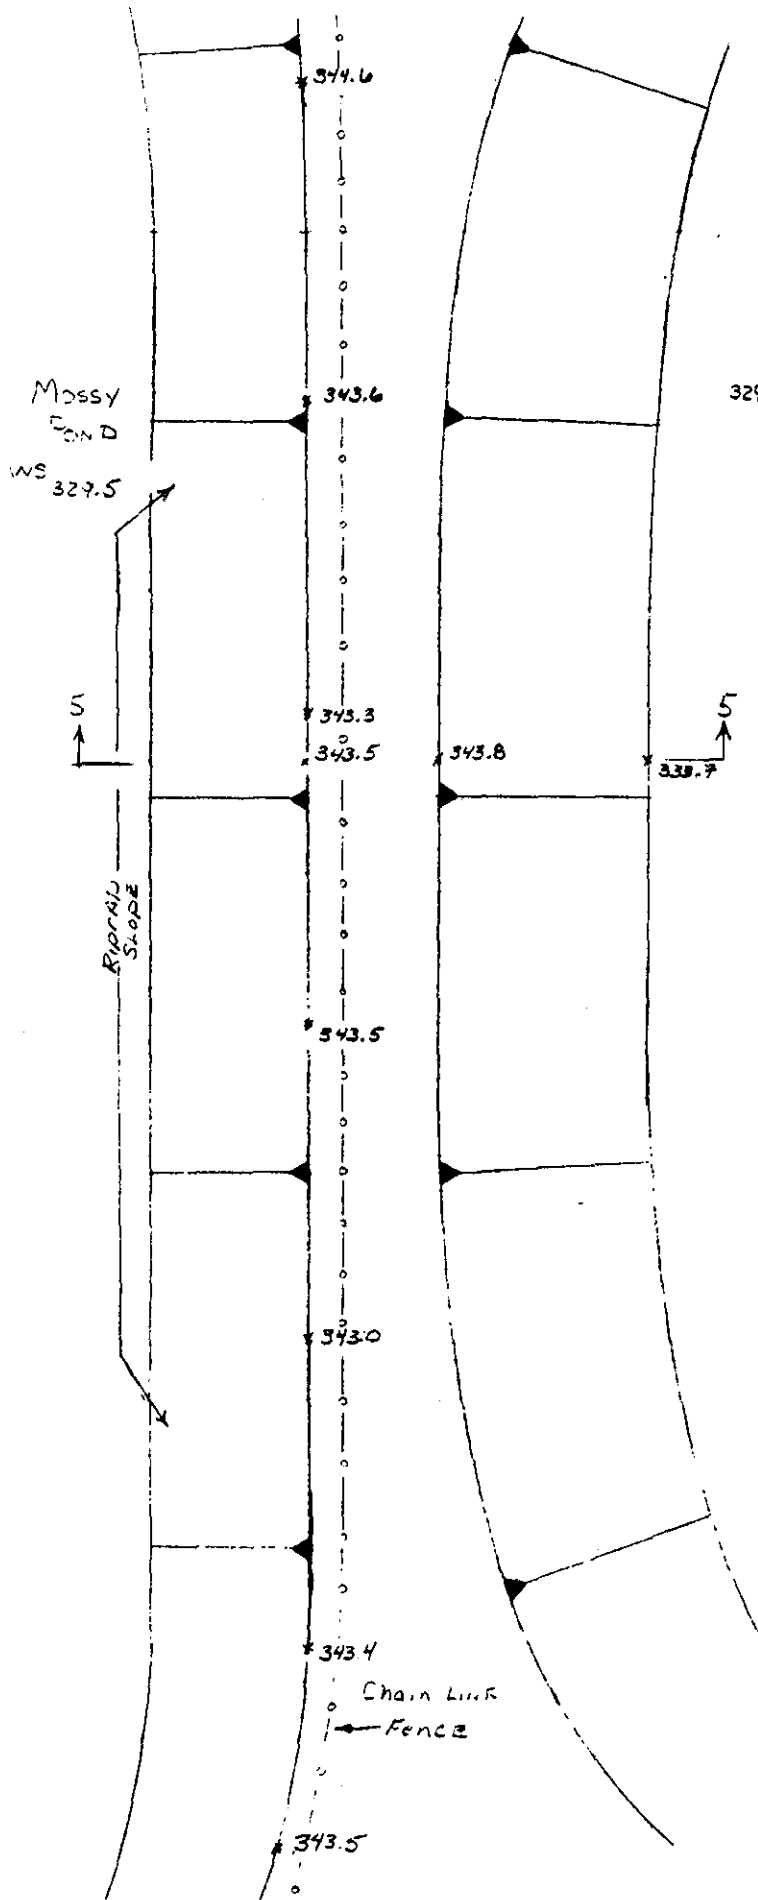
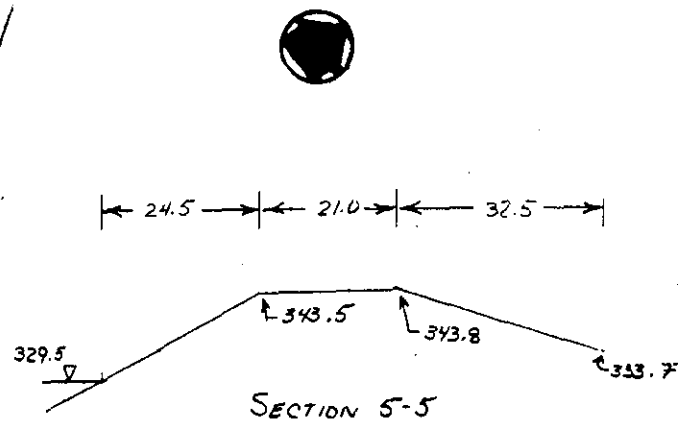
METCALF & EDDY, INC. ENGINEERS BOSTON, MA.	U.S. ARMY ENGINEER DIV. NEW ENGLAND CORPS OF ENGINEERS BALTIMORE, MD.
NATIONAL PROGRAM OF INSPECTION OF NON-FED. DAMS	
COACHLACE POND DAM	
FIGURE B-3 PLAN OF DIKE AND SECTION	
TRIBUTARY NASHUA RIVER	MASSACHUSETTS
SCALE: 1" = 30'	DATE: OCTOBER, 1978

The dike along the railroad tracks is in good condition. The crest and slopes are somewhat irregular. There is a footpath along the narrow crest and grass and brush on the slopes. Riprap has been placed on the slope facing the pond. No seepage or significant erosion was observed.

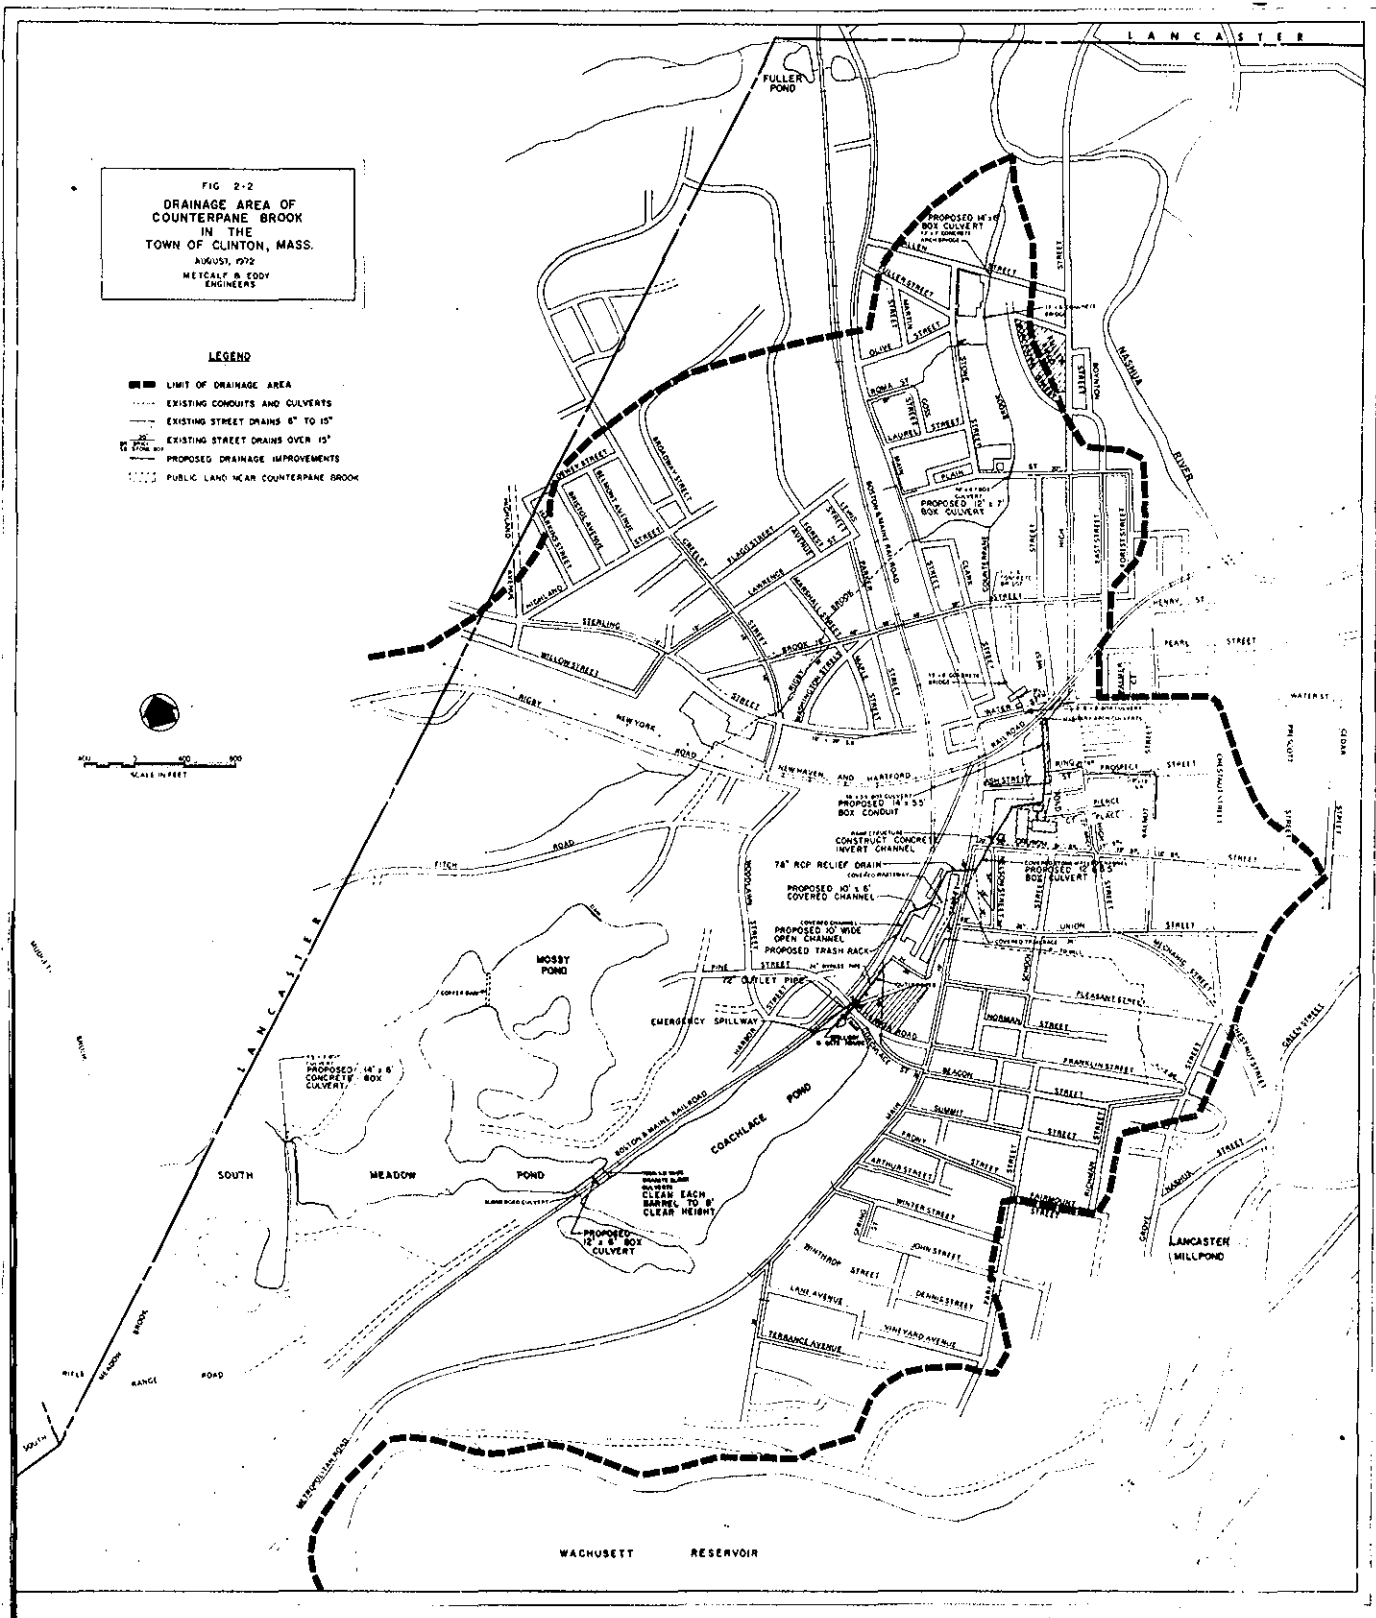
FIG. B-5 DRAINAGE AREA OF COUNTERPANE BROOK

A report dated August 21, 1972 was prepared by Metcalf & Eddy, Inc. entitled "Improving Flood Conditions in Counterpane Brook in the Town of Clinton". The report describes the channels and culverts along Counterpane Brook and the occurrence of past floods. Some data is cited in this report, and a plan and profile is included in Appendix B (see Figures B-5 and B-6).
